# GOLDEN FORENSICS TECHNICAL REPORT

Ruth v. Beartooth Electric Cooperative  
Inc, et. al.  
Case No.: 22-cv-00230-KHR

Clark Wildfire

November 15, 2021

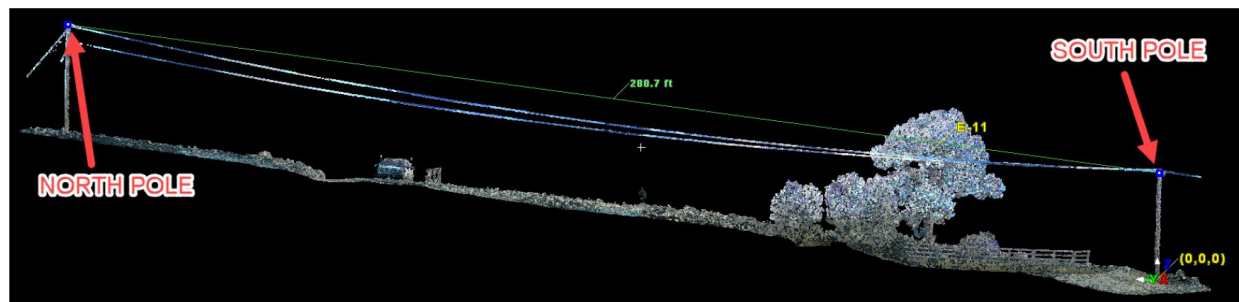
Figure 5: LiDAR Image of Conductor Span

The LiDAR measured the sag of the conductor to be 80 inches as shown in Figure 4. Notice the sag is the greatest in the middle of the span, but the subject tree is closer to the south pole, Figure 5. The distance the conductor can sway toward the tree at E-11 will be less than 80 inches, and therefore, the conductor would not be able to contact E-11.

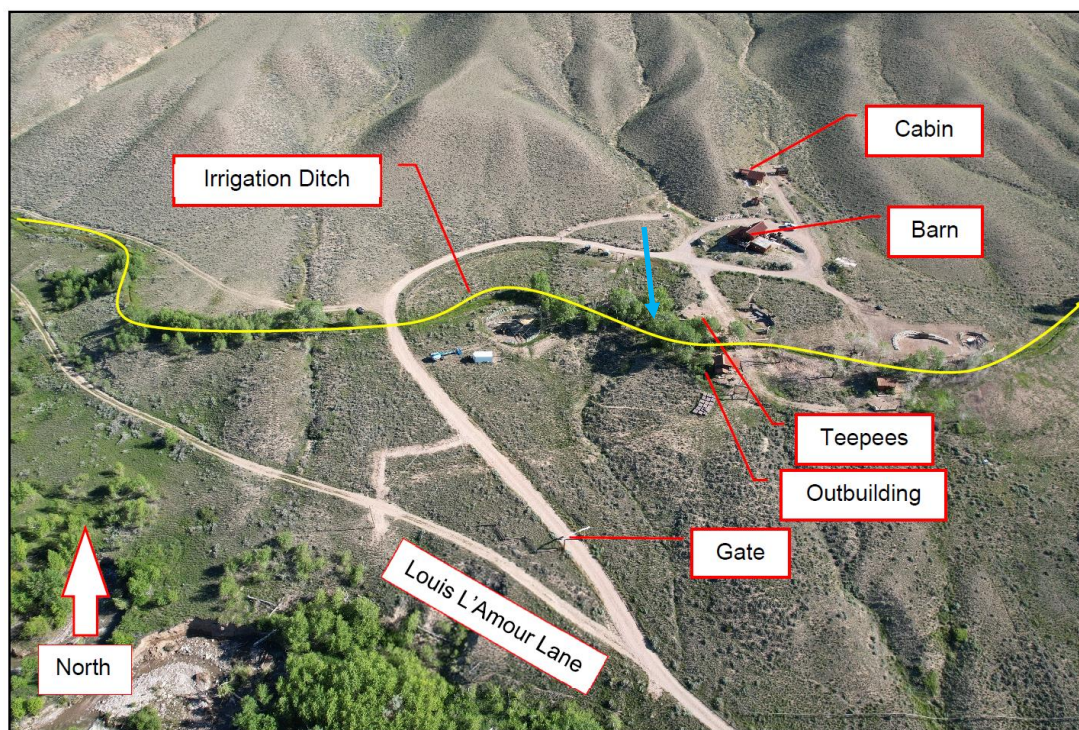
Figure 1 - Aerial view of the camp with callouts.

In the same paragraph on page 10 the report stated, "Twigs found near the outbuilding had areas of discoloration that were consistent with utility line contact." Two photographs taken by IRIS were referenced showing burned twigs on the east side of the outbuilding. This was well within the fire area. Figure 1 from the Jensen Hughes report is below showing the aerial view. The blue arrow indicates the Spot Fire 1 location. Notice the Outbuilding is east of this fire location. There were multiple burned trees around the outbuilding that it is more likely where the twigs were from, than the subject tree. Figure 13 is a view from the Outbuilding looking west showing multiple burned trees and lots of burned twigs on the ground. The subject tree is obscured by multiple trees.
